# PRODUCTS, INC.

## V & H AUTOMOTIVE 2003

**V&H AUTOMOTIVE IN MARSHFIELD, WI IS A LEADING AUTOMOTIVE DEALER AND ALSO SPECIALIZES IN HEAVY TRUCK REPAIR. THEIR SERVICE SHOP WAS IMPOSSIBLE TO CLEAN. GREASE, OIL, IMPACTED DIRT, AND OTHER FLUIDS COVERED THE FLOOR MAKING IT DIFFICULT FOR THEIR MECHANICS TO WORK, AND THE SHOP ALWAYS LOOK TERRIBLE TO CUSTOMERS.. WE DID WORK FOR THEM BEFORE AND THEY CALLED US AGAIN..**

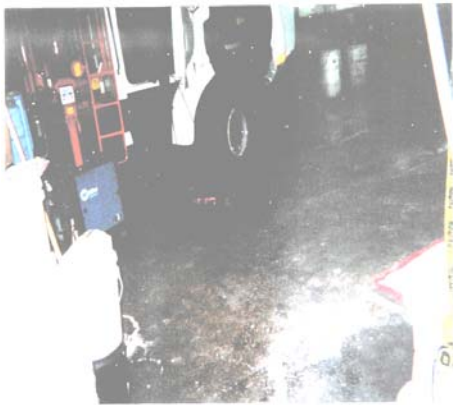
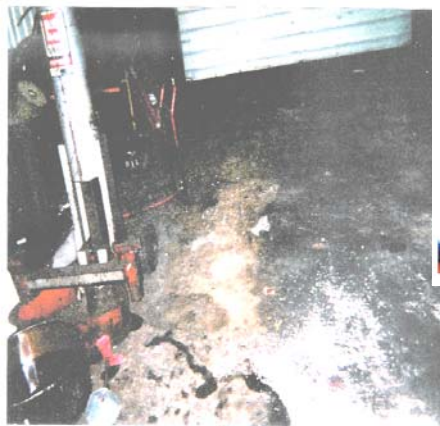
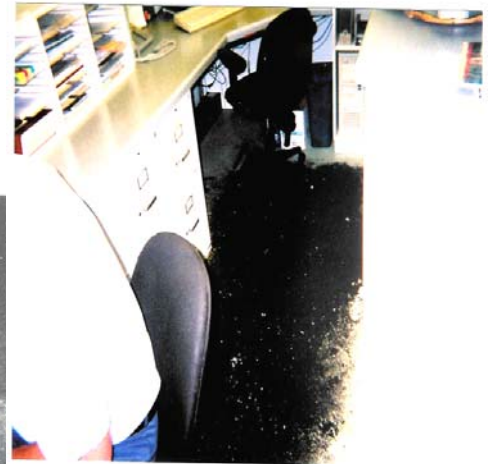
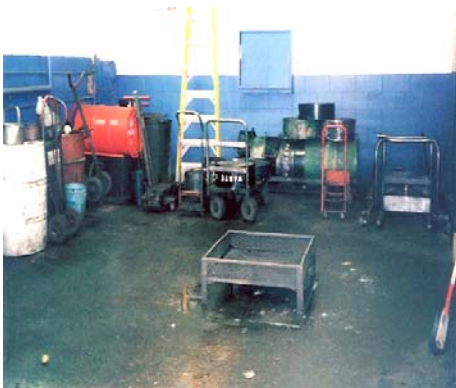
**THE SHOP WAS LITERALLY BLACK WITH GREASE AND OF COURSE THIS GOT TRACKED INTO THE OFFICES AND THEN ONTO THE RUGS BEYOND.**

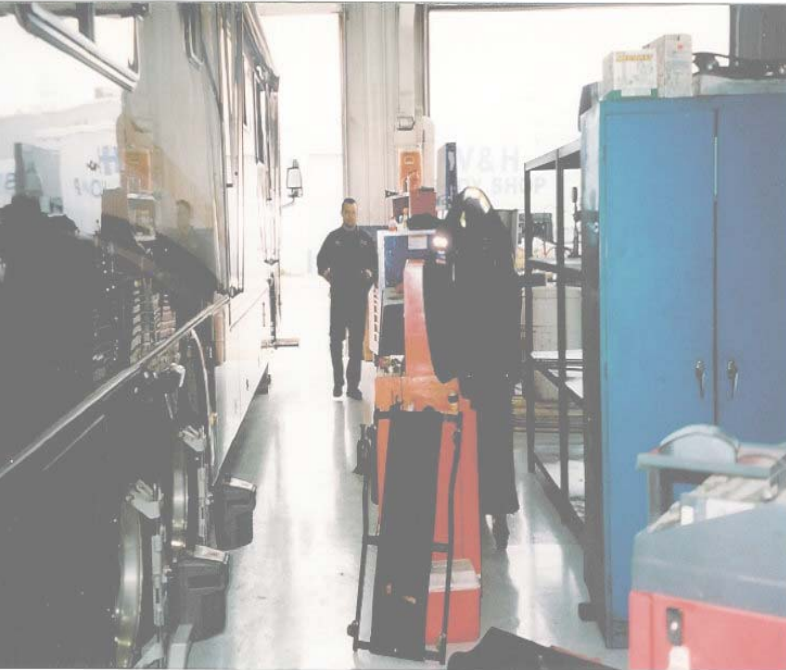
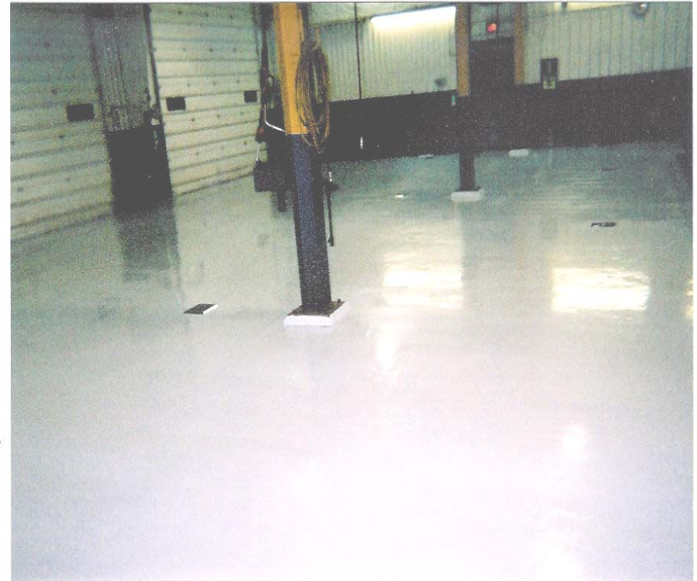
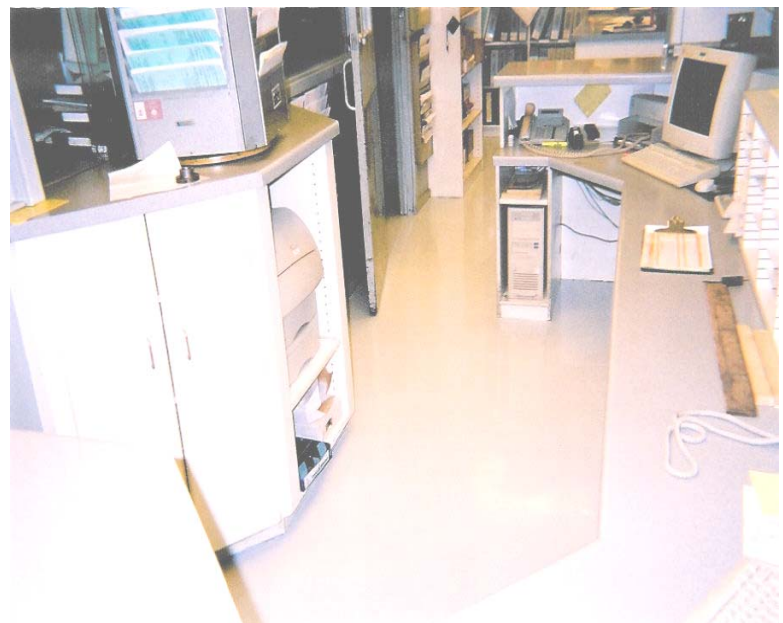
**THE RESULTS:**

**CLEAN**

**BRIGHT**

# AND VERY REFLECTIVE OF A WELL RUN OPERATION
